Phantom satellite?

STS-88 “whatsit” and the ‘Black Knight’ legend

The STS-88 mission

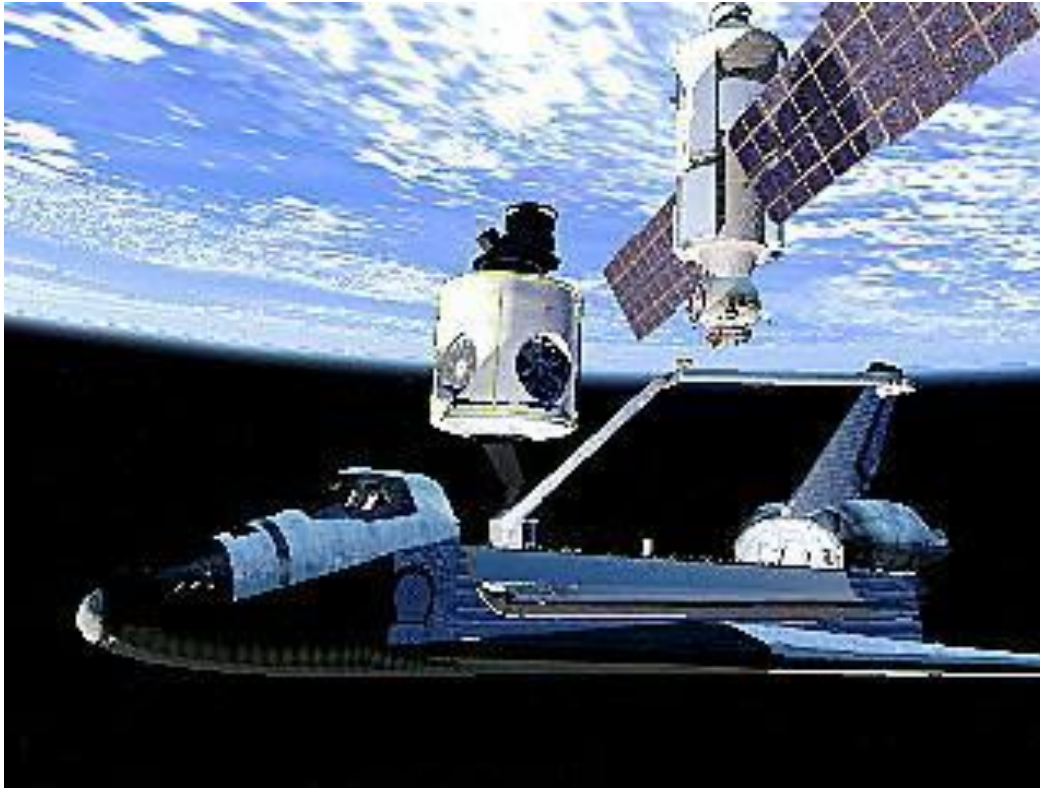
Mission: Link first two ISS elements

- Bring up Node-1, mount it atop airlock
- Rendezvous with already-launched FGB [from Russia]
- Grapple it with Canadian robot arm “in the blind”
- Berth it atop Node-1 “in the blind”
- Spacewalks for outfitting, connecting; brief internal visit as well
- Oberg trajectory role -- <http://www.jamesoberg.com/orbits14.pdf>

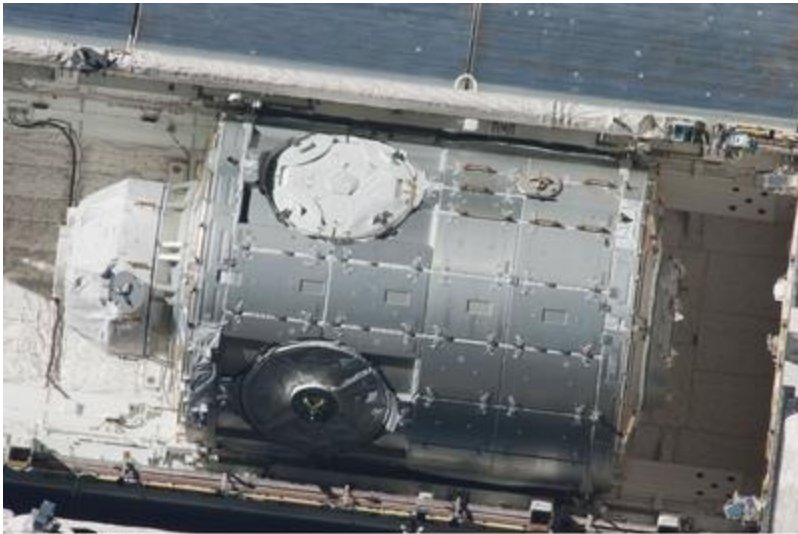
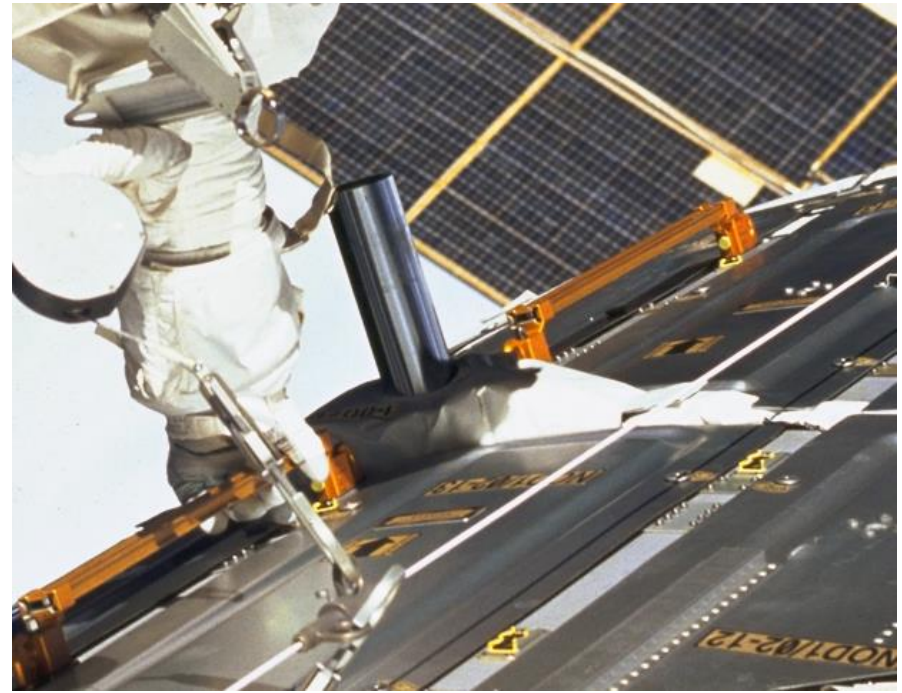
Trunnion pins

- One of the EVA tasks was installing thermal covers over the four trunnion pins on the Node. These are the stubby poles extending from its sides that had locked into sockets along the wall and keel of the Space Shuttle Orbiter's payload bay during launch to docking. Attached to round 'skid plate'.
- Once the node was deployed, the trunnion pins were useless. But as bare metal, they were 'heat leaks' into space. Strapping a blanket over each one would save a lot of power, since now it would not be needed for heating.

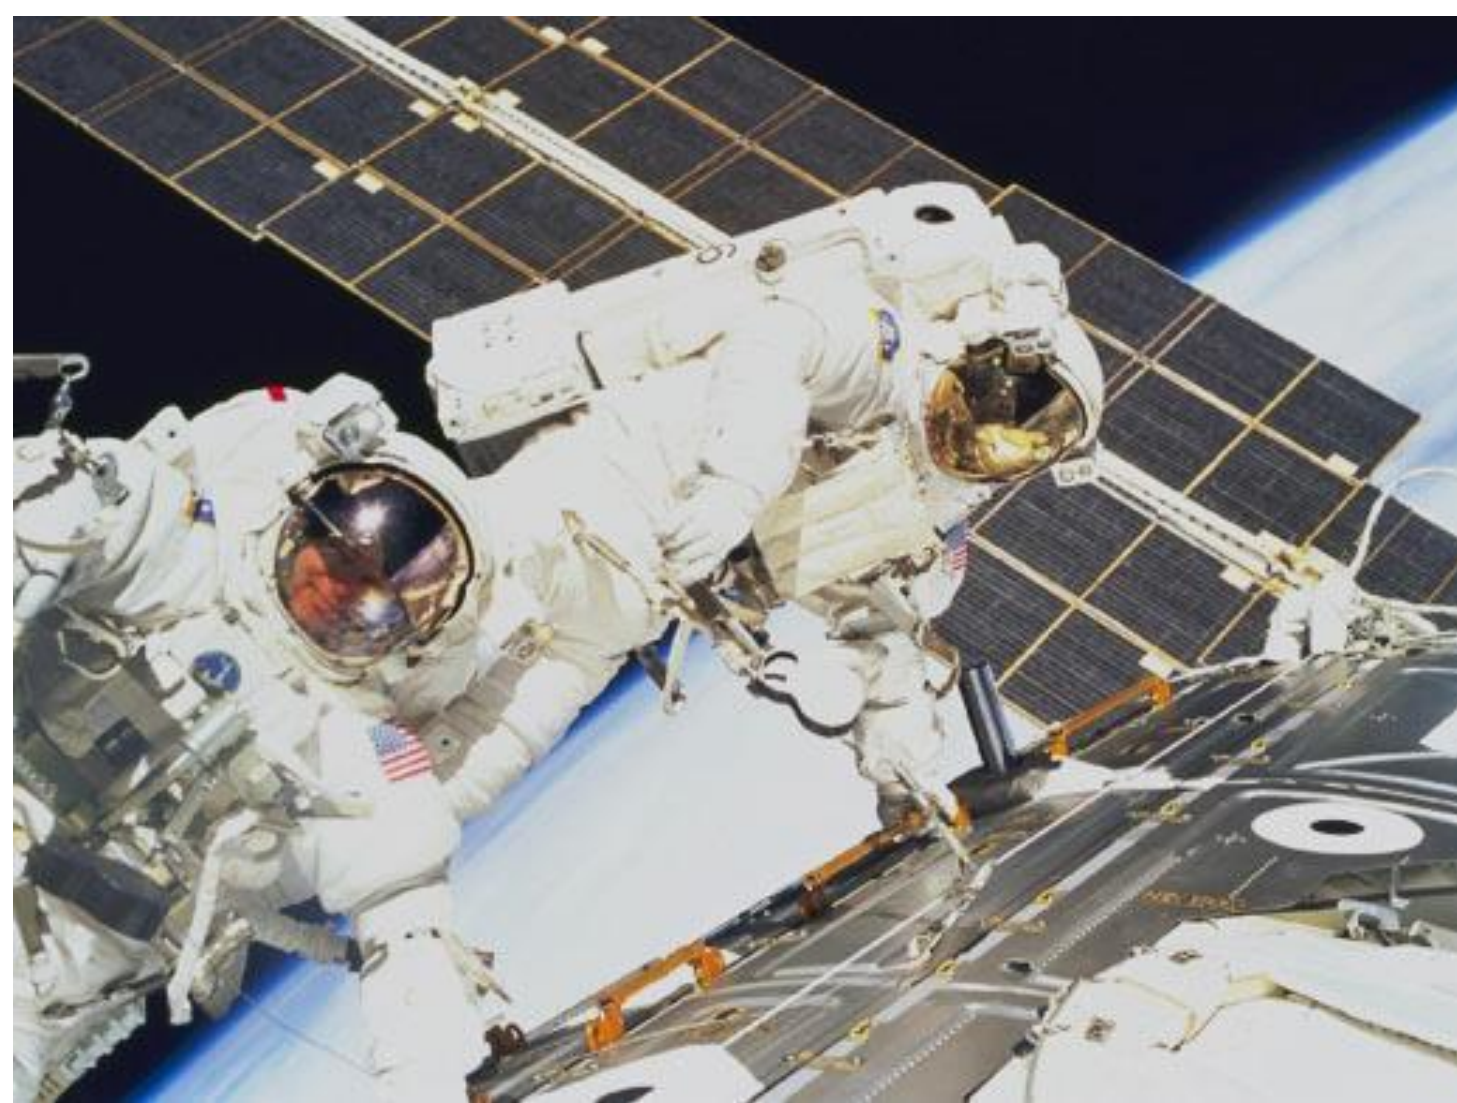
Thermal cover fabrication

- The insulation blanket would need a 'sleeve' to slip over the long trunnion pin itself
- It would also need a reflective flat circular covering for the round metallic skid plate
- It would need flaps at points along the plate's circumference to easily attach to existing frames on the module, using bulky gloves
- It would have to contain handling loops and tiedowns for transport by the spacewalker
- It would need to fold up for stowage inside the shuttle cabin and to pass through hatches

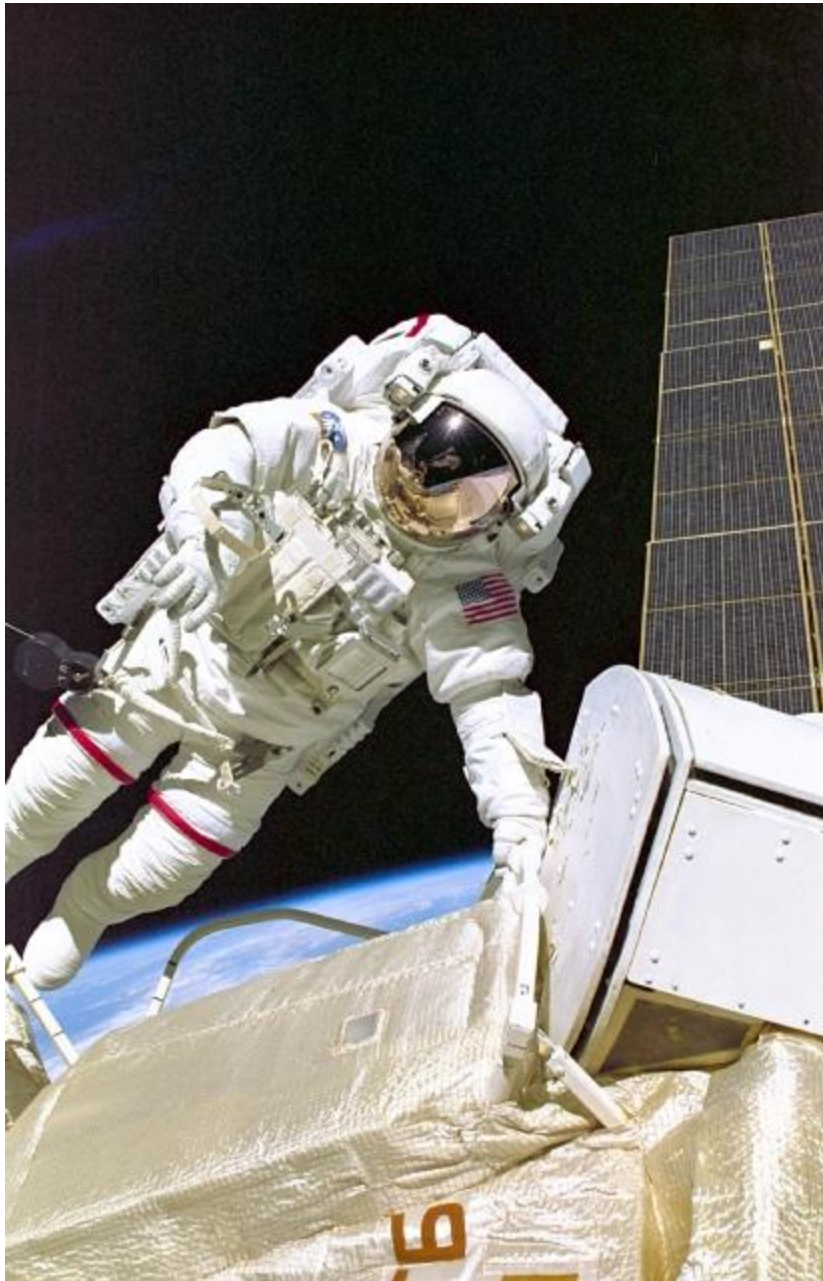
Different blankets on Russian FGB

The second thermal blanket photo is on the Russian FGB module -- you can see the Cyrillic letter 'B' on the panel -- and none of them were dropped this time.

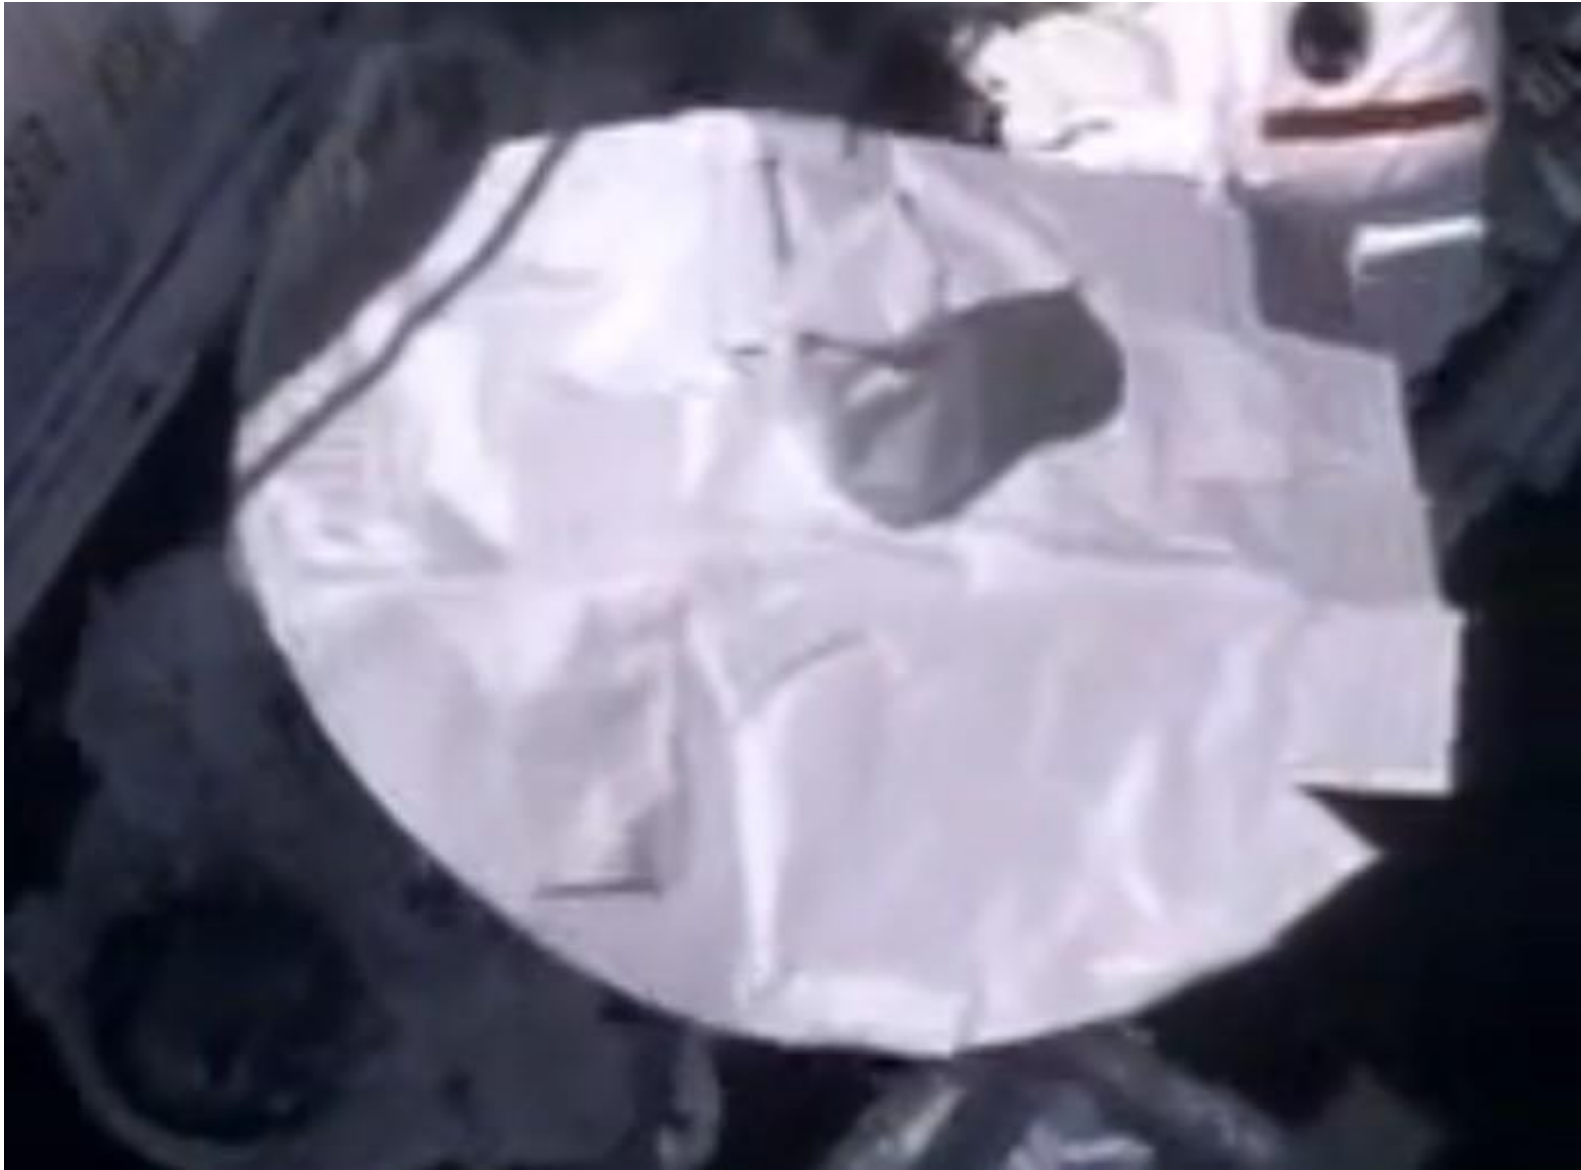
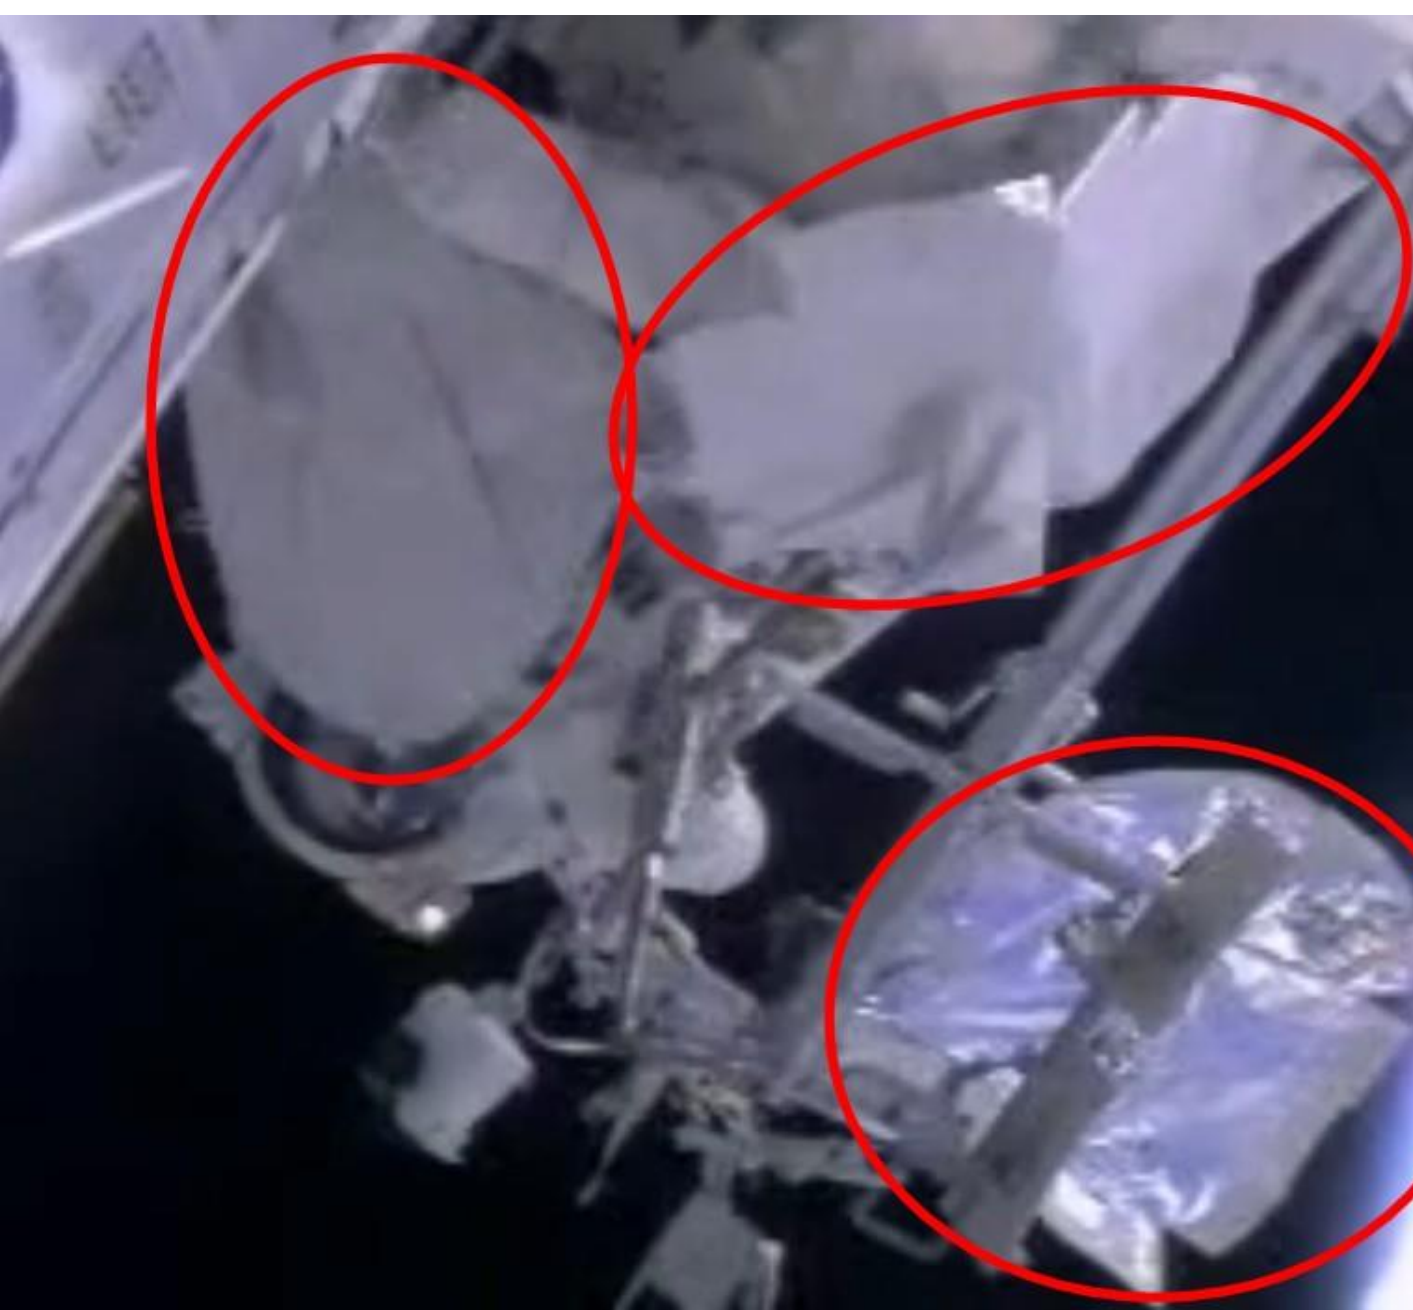
Thermal blanket ready to install

EVA video of
3 blankets
awaiting
installation,
tethered
loosely to
astronaut
spacesuit
belt.

Three covers shown. Flat white top, silver underneath, pin 'sleeve' centered.

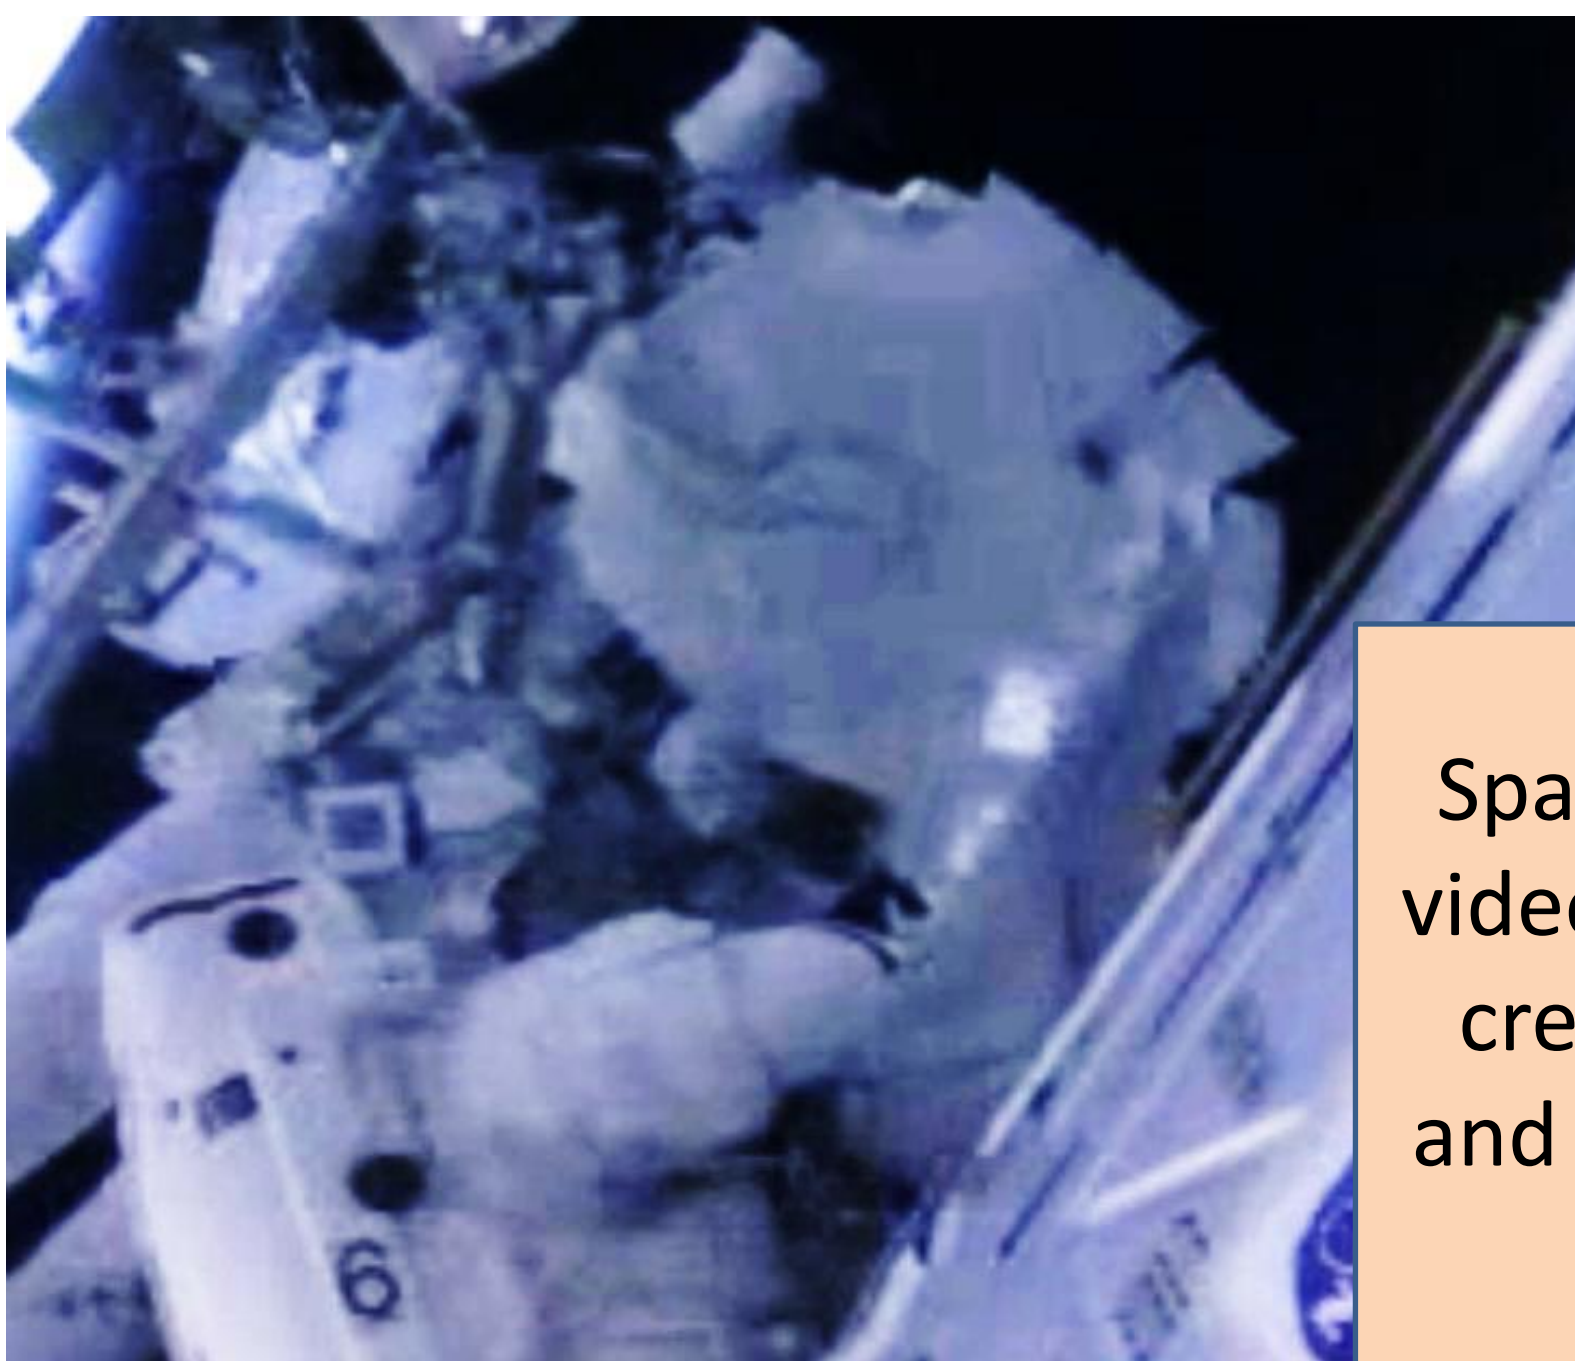
Spacewalk
video shows
crewmembers
and blanket

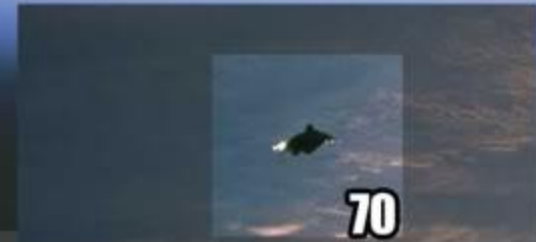
Tumbling motion

frames 65-69 - rotated to match Earth's curve - scale consistent - cloud patterns matched with steady offset

frames 69-70
separate fix, deeper zoom
cloud pattern-matched
scale consistent

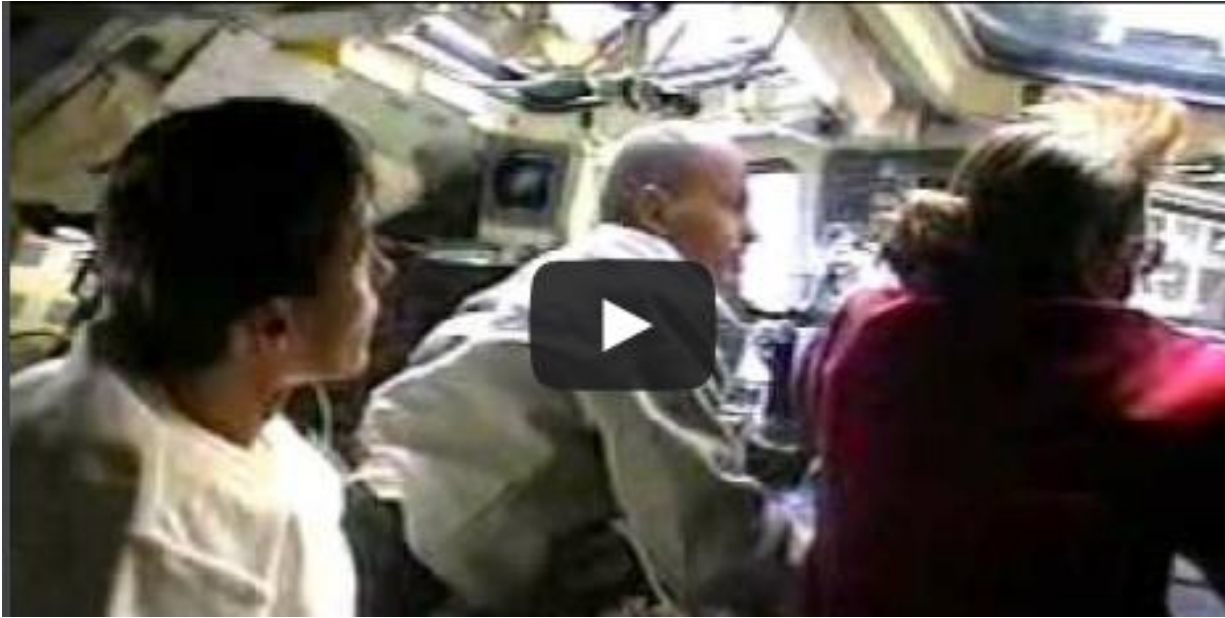
NASA video orbiter aft flight deck during spacewalk when blanket is dropped

You can see copilot Rick Sturckow at the left window, Nancy Currie at the right window, Sergey Krikalyov with the Hasselblad getting those detailed still images.

There's a long sequence of the slowly-tumbling thermal cover, clearly the same object previously misidentified as the 'Black Knight' satellite. It's viewed through a dirty window but the shape is unmistakably the same

The videos should convince any observant, perceptive person that the “Black Knight” stills are just higher-resolution snapshots of the same object seen in both videos: a thin, shiny thermal cover, one of several meant to be installed during the second spacewalk. But the "one that got away" -- and soon burned up.

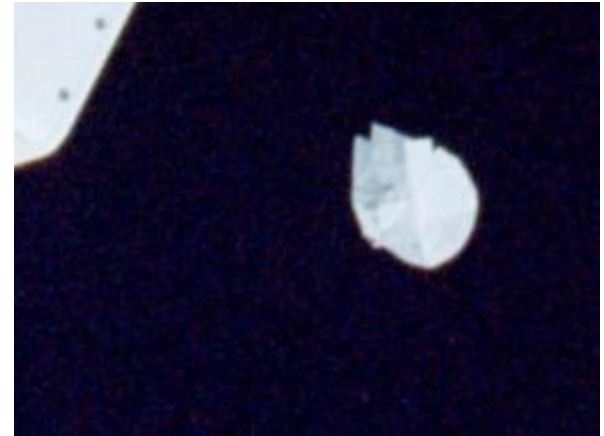
Here's a still of the dropped thermal cover while it was still close to the Node. The irregular shape should look familiar, the reflected light seems different from a different angle.

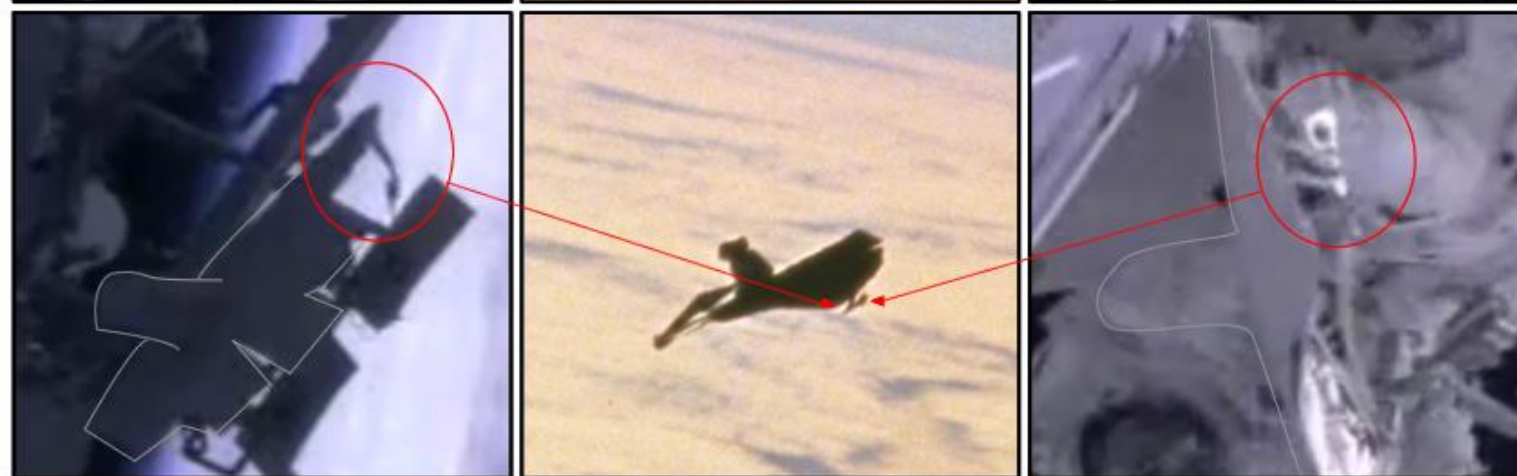
Matching exact features of video of thermal blanket with famous still of “unidentified” object.

The notorious still photographs that have been identified as the ‘Black Knight’ were taken from inside the cabin [one video shows the crewman while he is actually taking them], and show the same-shaped object, with the shiny reflective side facing space and thus looking pitch black. Even the sun gleams are the same.
